February 21, 2011 Project Number 070181

Subject: Work Plan for Sedimentation Basin Restoration- Waimanalo Gulch Sanitary Landfill, Ewa Beach, Oahu, HI

ATTACHMENT A

ATTACHMENT B

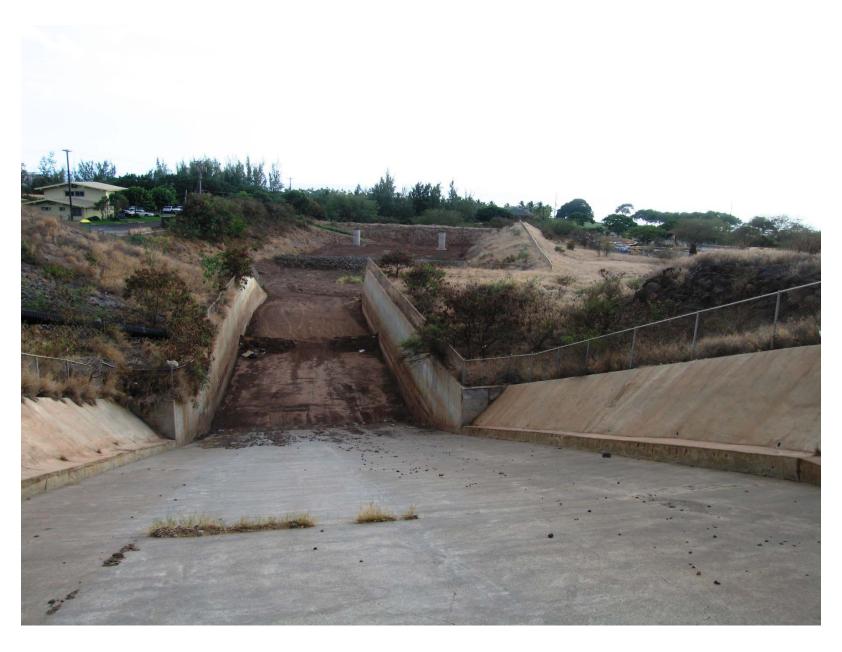
View of Basin Looking South Along the Western Concrete-Lined Drainage Channel

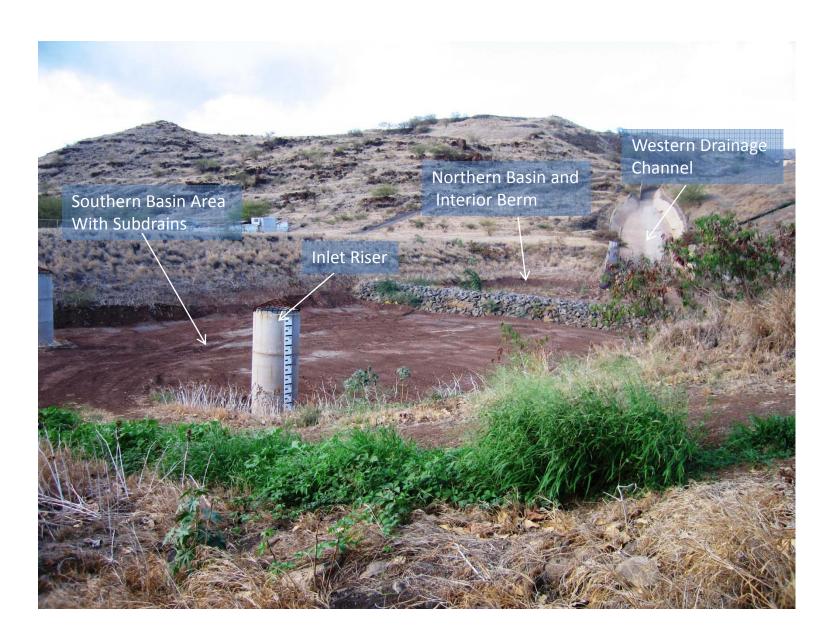
View of Sedimentation Basin Looking North

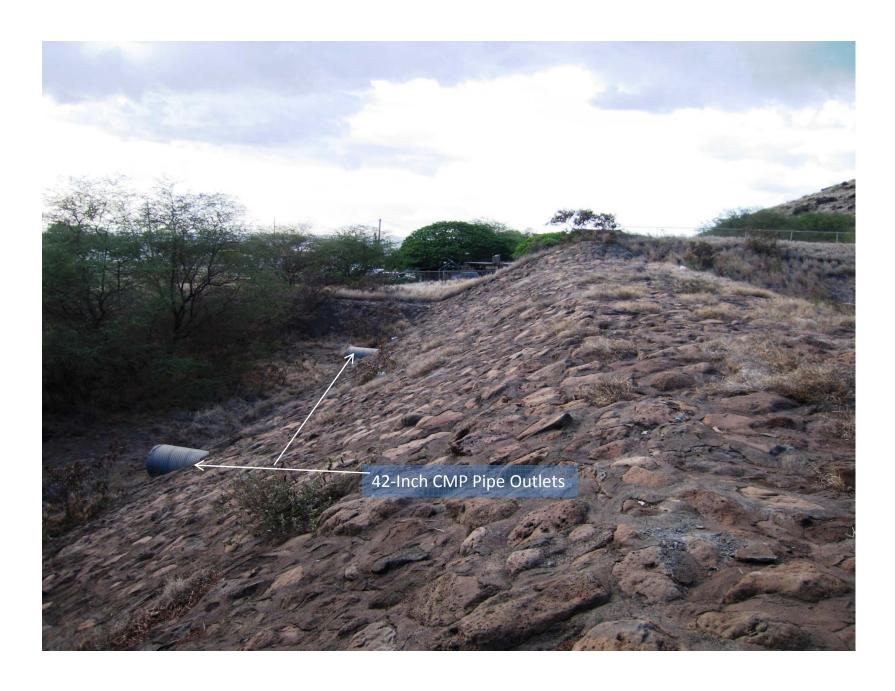
View along Riprapped Embankment Crest Looking West

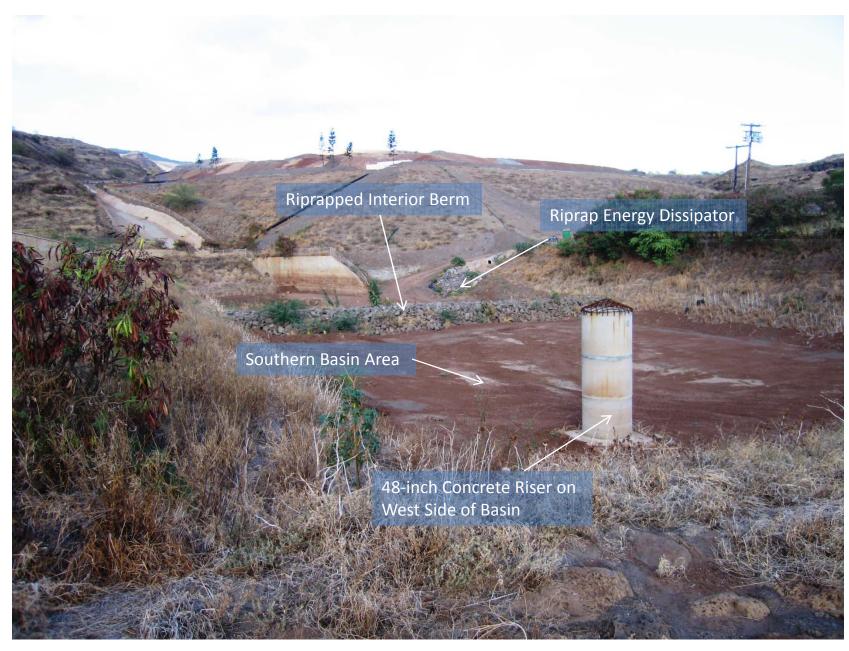
View of Basin Looking Northeast from Riprapped Embankment Crest
